EARTHQUAKE SPECTRA

Local site effects and incremental damage of buildings during the 2016 Central Italy earthquake sequence

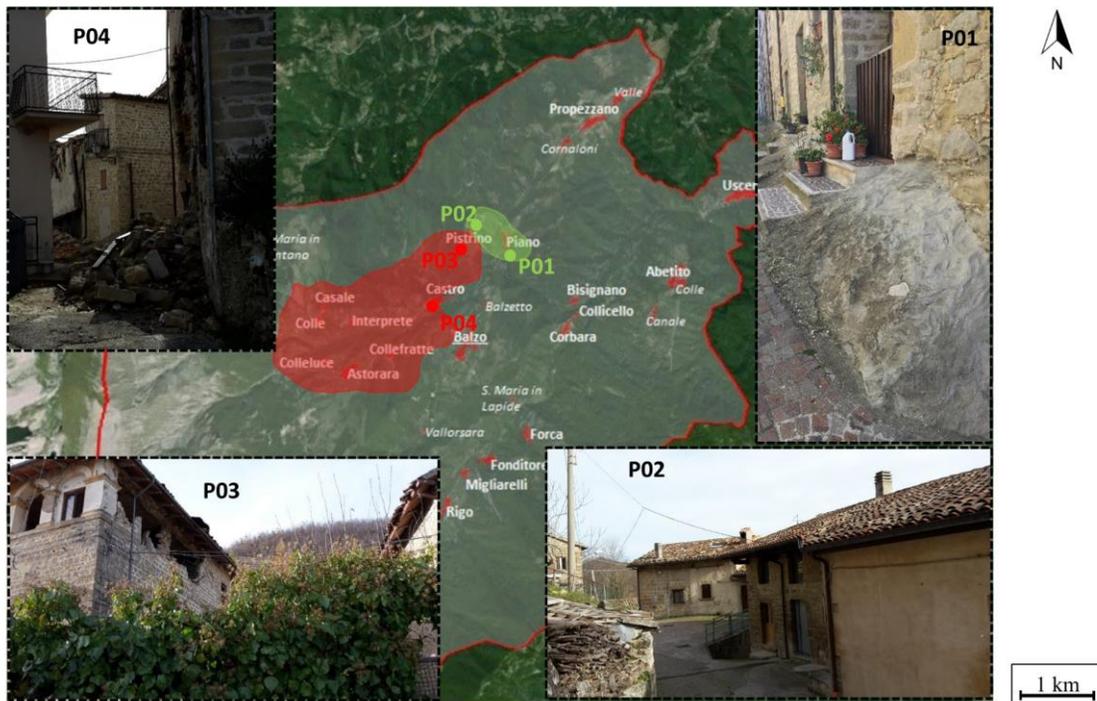
Other Montegallo's hamlets, such as Astorara, Castro, and Colleluce in the southwestern part of the area at a distance of 1.5 to 2.5km from Piano, located on quaternary deposits resting on rock, experienced high levels of damage and several cases of total collapse (D5). For example, Figure 3-P04 shows a street in Castro that was blocked by the debris of a damaged building. Given the proximity between Castro (highly damaged) and Piano (practically undamaged), and the very similar structural systems and construction standards, it is probable that Castro experienced stronger ground motions than Piano, due to significant topographic amplification. A view of the 3D model obtained with a drone survey over the entire area can also be found in BYU-PRISM (2016). It shows the typical crest configuration of the zone, leading to possible 2D topographical effects.

Figure 3. Spatial distribution of building damage across the municipality of Montegallo.

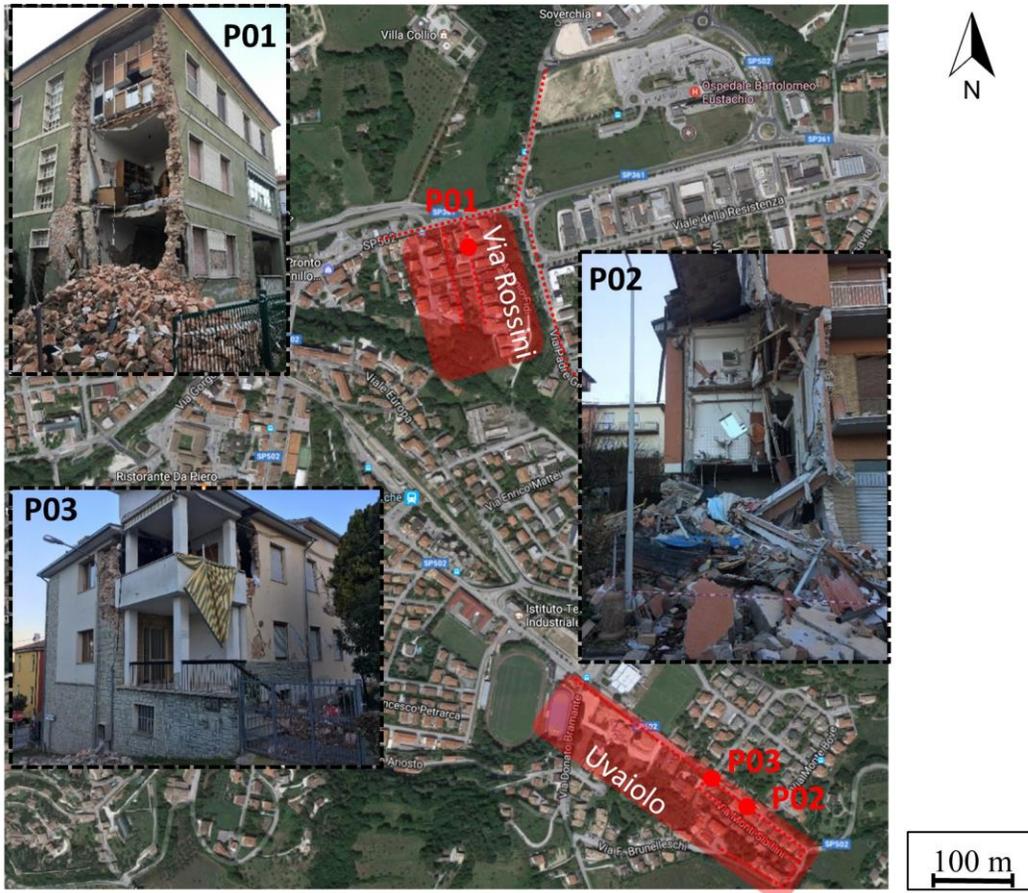
Other examples of local site effects were identified in some areas of San Severino Marche (number 11 in Figure 2). San Severino Marche is a town in the Province of Macerata, in the Marche region, located about 50 kilometers south-west of Ancona and about 25 kilometers south-west of Macerata. It has about 12,000 inhabitants, and it comprises more than 40 hamlets. Unlike Montegallo, San Severino has districts where most of the buildings are of reinforced concrete, built in the 1960s and the 1970s. Within San Severino Marche, two neighborhoods along Via Mazzini and Via Rossini attracted most of the GEER reconnaissance team attention due to the evident and quite localized damage observed (Figure 4). Via Mazzini is located uphill while buildings along Via Rossini are constructed on the ancient riverbed of the Potenza River. It is deemed that stratigraphic amplification is likely to have taken place due to the presence of soft shallow sediments resulted from the river artificial channeling operations. Similar damage patterns and site effects have been observed in Tolentino (number 10 in Figure 2), as described in GEER (2017).

Figure 4. Characteristic building damage within the town of San Severino Marche.

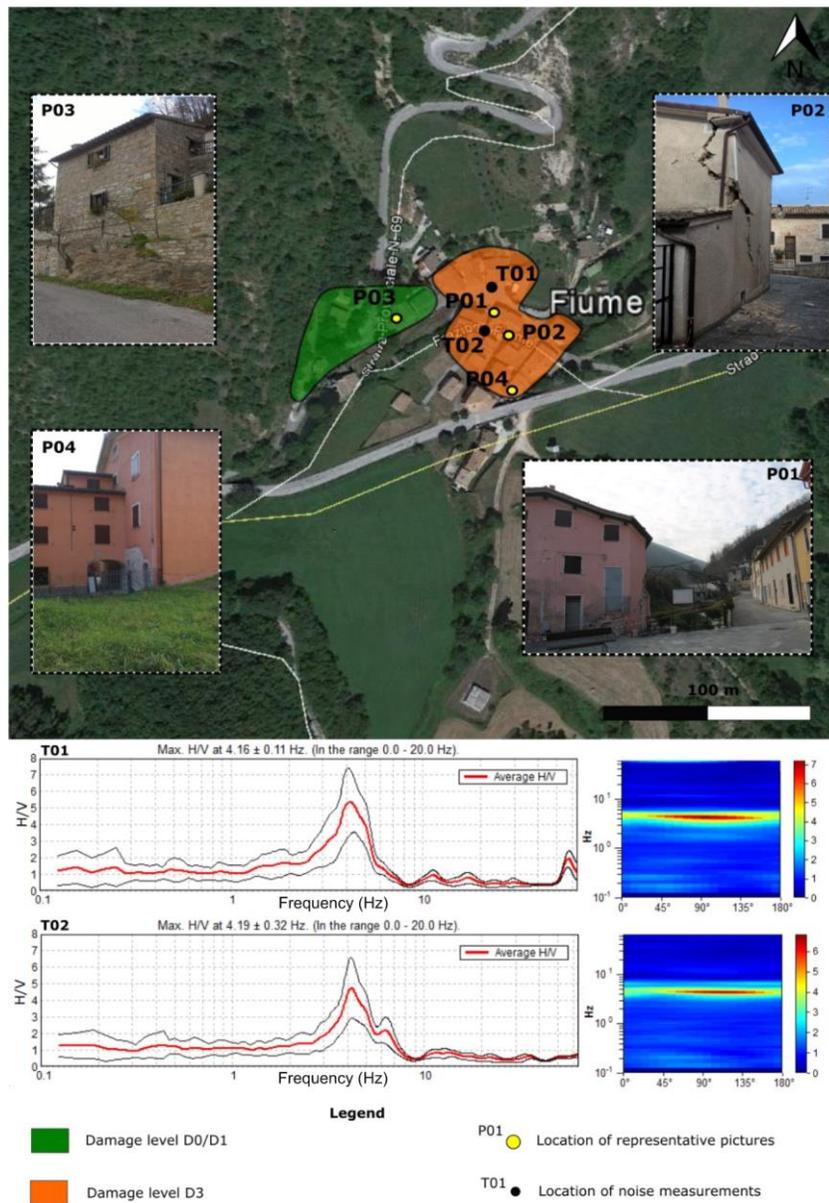
The Fiume building stock consists mainly of low-rise unreinforced masonry structures, some of which retrofitted to some extent. Locations and pictures of representative structures inspected in Fiume are reported in Figure 5 illustrating the severe and extensive damage. Notably, the degree of damage to buildings was highly variable across the village. The

eastern part of the hamlet, founded on colluvial and alluvial deposits resting on bedrock, suffered high levels of damage (D3) as shown in reference pictures P01-P02-P04, whereas the western part, built on travertine rock, had only negligible damage (D0/D1, P03).

Two noise measurements (T01-T02 in Figure 5) were performed in the damaged zone (east side of the hamlet) during the GEER mission. A portable Tromino tomograph was employed and the total duration of each measurement was approximately 15 minutes. Horizontal-to-Vertical (H/V) spectral ratios were computed by using the geometrical mean of horizontal components. In addition, H/V ratios were computed by rotating the horizontal component between 0° and 180° (directional or polar HVSR), in order to investigate preferential directions of site amplification (i.e., the polarization of ground motion). Both H/V and polar H/V are reported in Figure 5 showing a large H/V peak around 4 Hz, which shows significant stiffness contrast between the upper soil layers and the underlying bedrock, i.e. a typical proxy of local site amplification.

Figure 5. Damage zonation within the village of Fiume (up). Location and results of noise measurements in terms of H/V spectral ratio (bottom left) and polar plot (bottom right).

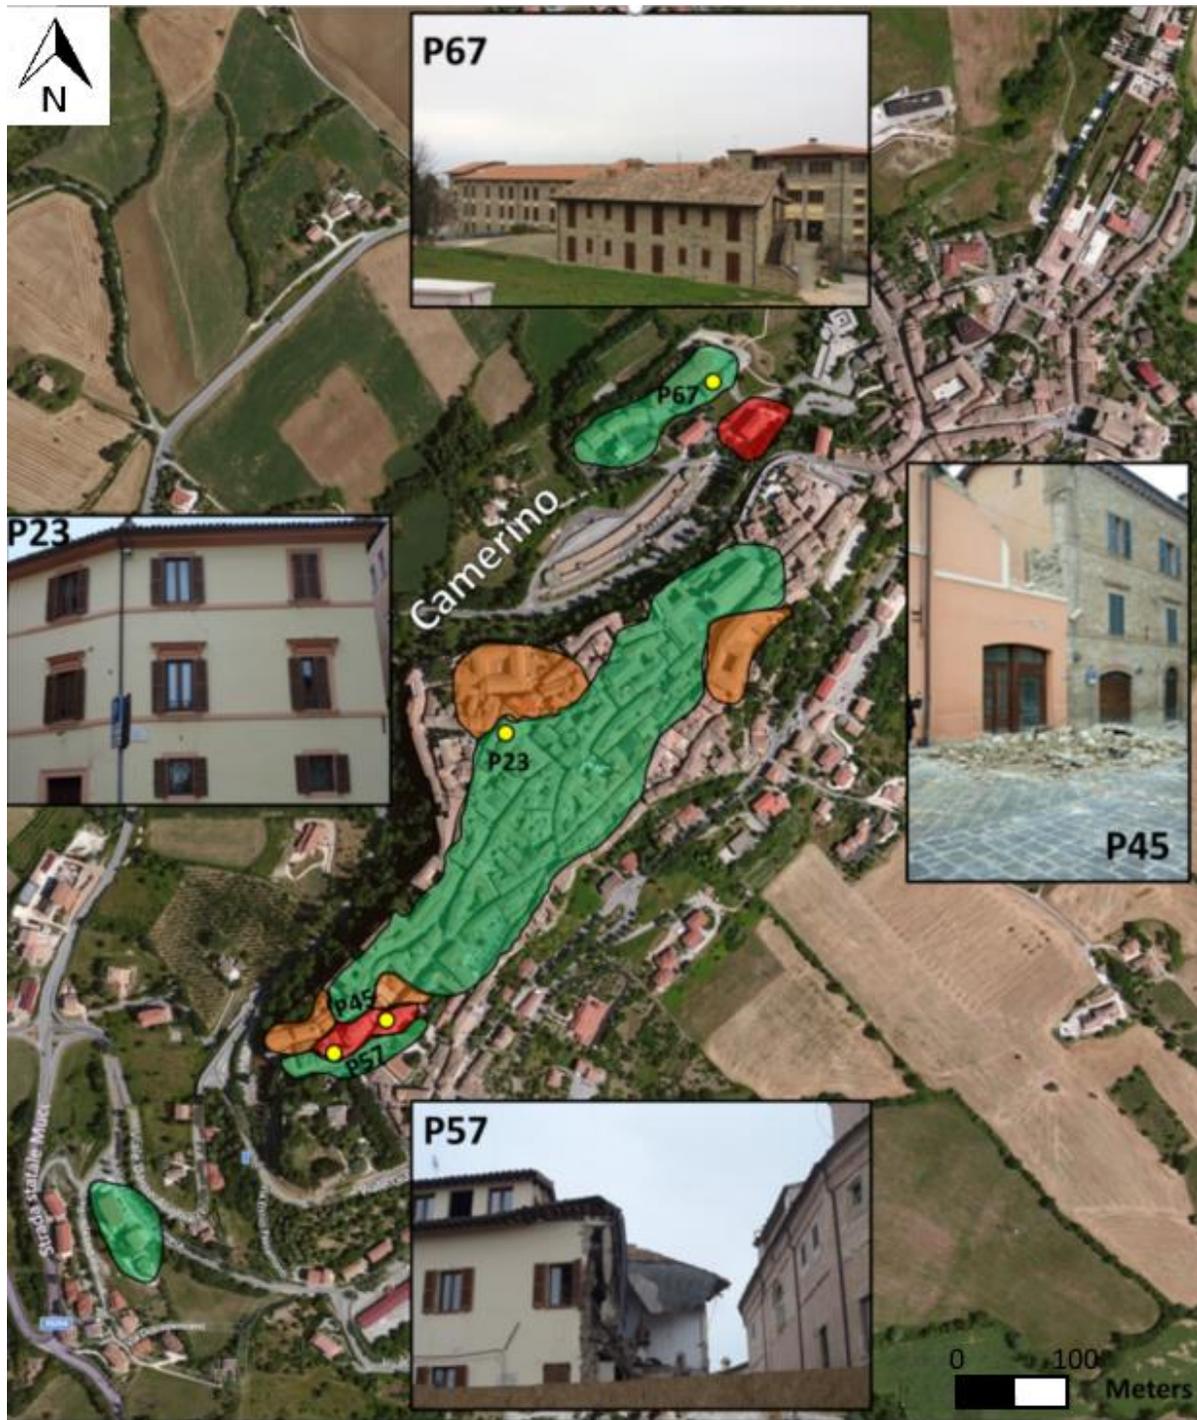
Figure 6 depicts the damage distribution across the main village, as inspected after the 30 October event. Relatively low damage (D0 or D1) were observed within the inner part of the ridge characterized by local bedrock (GRS) outcrops. Higher damage levels (D2-D3) were observed for many of the low rise (2-3 stories) unreinforced masonry buildings, even if some of them were partially retrofitted. The damage is mainly localized on the hillside, where potential topographic amplifications and permanent deformation (due to slope instability) may be occurred. The highest damage level (D4) was observed at the SW side of the historic center and at the bottom of the Camerino hill, where several masonry structures collapsed. The observed damage distribution pattern in Camerino is consistent with site effects that could be inferred from the geological map shown in Figure S5. Strong amplification of earthquake ground motions is highly probable given the thin soft layers of eluvio-colluvial soils (ML) overlying the bedrock.

Figure 6. Damage zonation within the historic center of Camerino with pictures of the representative structures inspected.

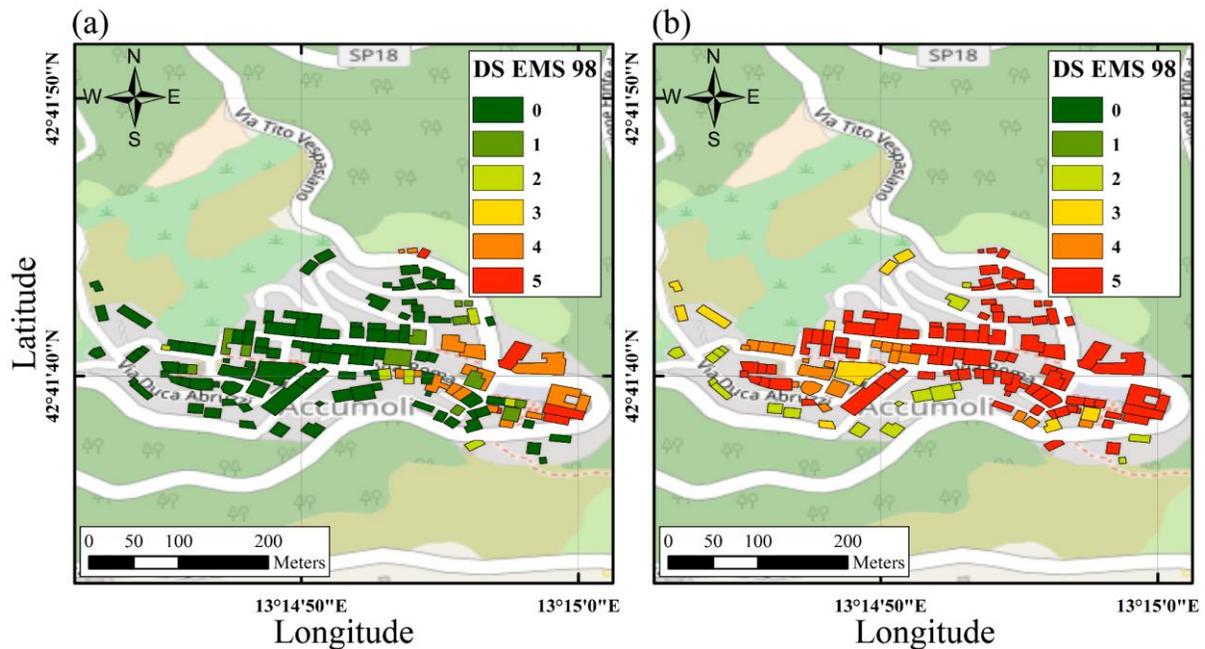
Figure 7 illustrates the structural damage levels observed during the two surveys, after the 24 August (left) and the October events (right). After the August 24th event, the most severe damage was observed at the eastern side of the village, while the vast majority of the building stock retained its structural integrity null or with minor damage (D0-D1). However, at the end of the seismic sequence, Accumoli was almost completely destroyed. Few buildings, in the south end of the village survived the sequence of events with limited damage (D2).

Figure 7. Damage levels in the main village of Accumoli (a) after the first earthquake and (b) at the end of the entire sequence.

The evolution of structural damage during the earthquake sequence is clearly reflected in the observed damage: 72% of the buildings experienced zero (DS0) and 8% minor damage (DS1) after the first earthquake, while not a single building was found intact or with minor damage after the seismic sequence. Large damage states were in contrast more populated (4% to 13% for DS2, 0% to 7% for DS3, 12% to 14% for DS4, and a major shift from 4% to 65% for DS5).

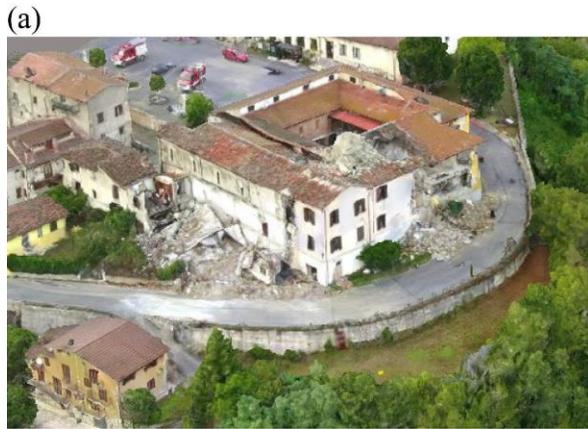
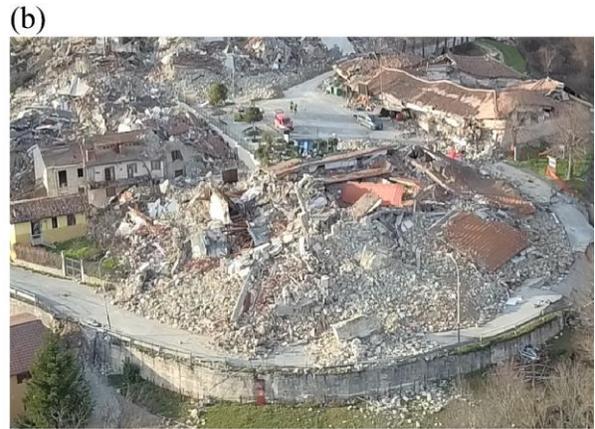
Figures 8a and 8b show an aerial view of the east part of the village during the first and the second surveys, respectively, including the local church and the police station, which eventually collapsed because of multiple earthquake excitations. Figures 9, 10 and 11 illustrate characteristic cases of minor-to-moderate shear and out-of-plane damage after the August event that led to abrupt collapse because of the earthquake sequence. Age of construction, high spectral accelerations for periods lower than 0.3s (which match the natural periods of low-rise buildings) and the variation of spectral polarization across several events were likely the main contributors to the observed catastrophic damage patterns. Given the location of Accumoli, topographic effects may also have contributed to the observed damage.

Figure 8. Aerial photos of the east side of Accumoli after (a) the first earthquake and (b) the entire earthquake sequence.

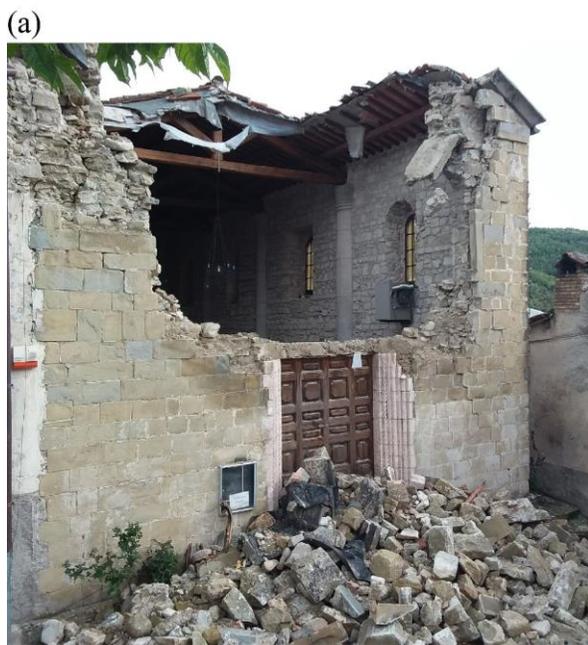
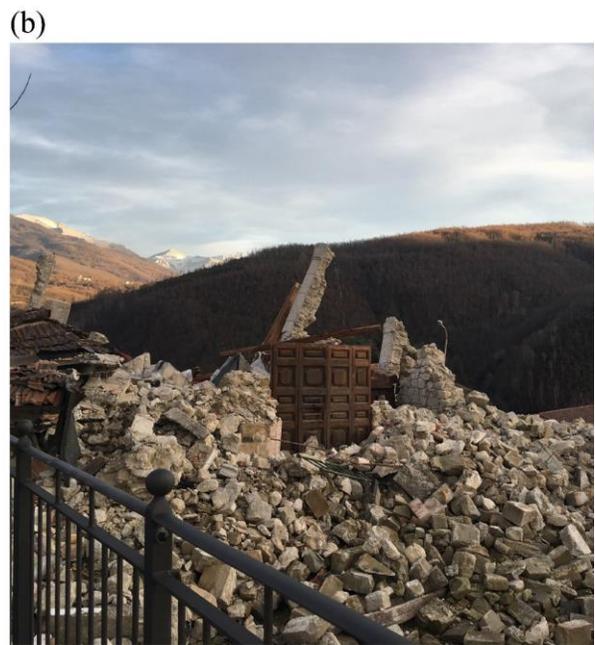
Figure 9. The local church: (a) after the first earthquake; and (b) after the entire sequence.

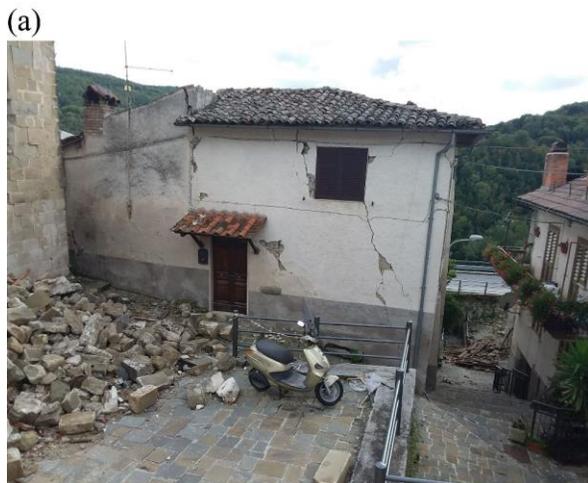
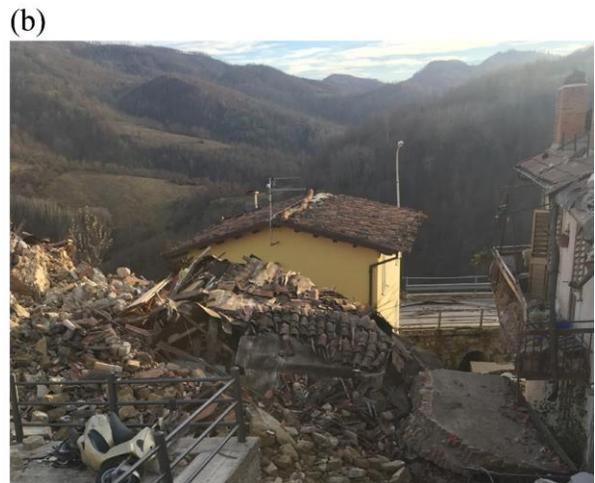
Figure 10. Masonry residential building: (a) after the first earthquake; and (b) after the sequence.

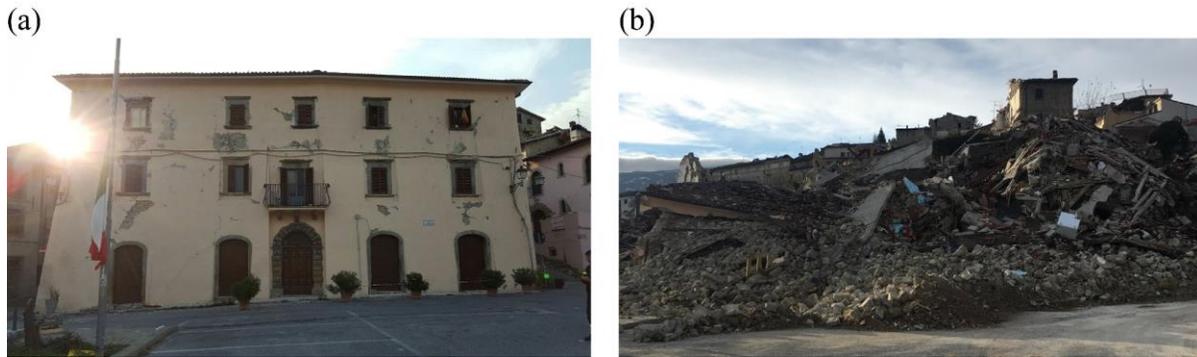
Figure 11. The town hall: (a) after the first earthquake; and (b) after the entire sequence.

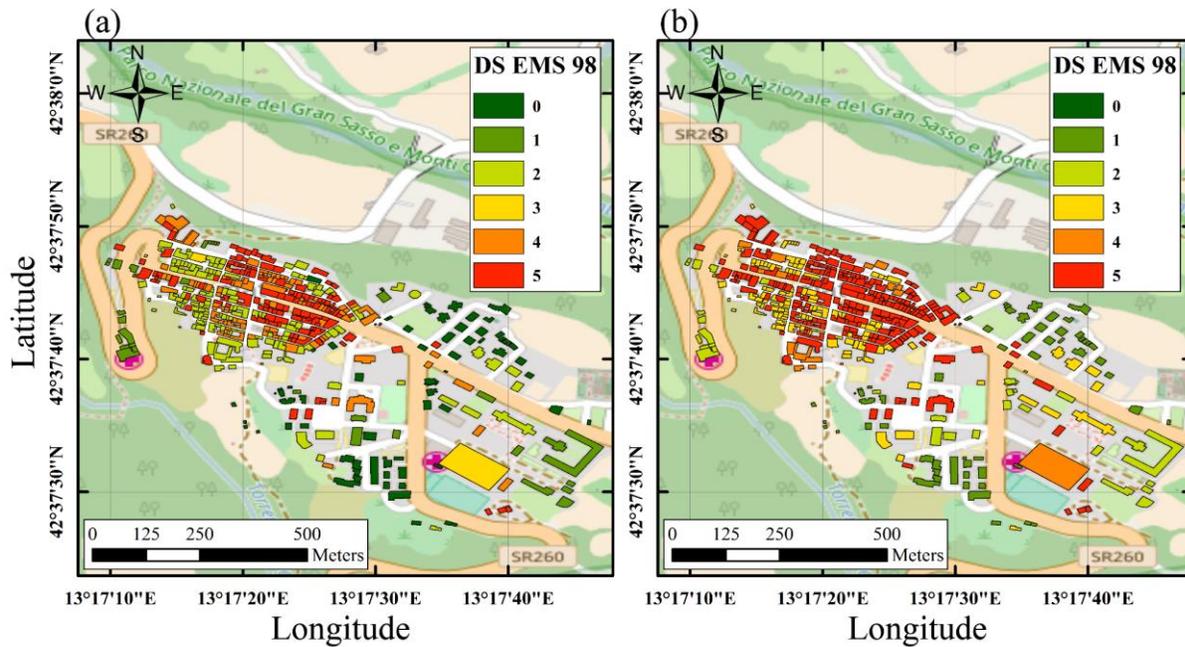
Figure 12 shows the structural damage levels observed during the two surveys. The 24 August event caused severe damage to the south-east part of the historical city center along the main avenue (Corso Umberto I). As observed in the case of Accumoli, many buildings that were still standing after the first event with only a small residual capacity to additional horizontal actions, fully collapsed because of the subsequent September and October events. The shifting of damage states between the aftermath of the first event and the end of the

entire sequence is reflected in the following inspection results clearly indicating a major shift to most critical damage states: intact buildings (D0) were reduced from 30% to 18%, buildings with minor damage (D1) were increased from 5% to 10%, moderate damage (D2) was reduced from 24% to 6%, D3 increased from 1% to 21%, D4 decreased from 17% to 3%, and collapsed buildings (D5) had a significant increase from 23% to 42%.

Figure 12. Damage levels observed in the center of Amatrice (a) after the 24 August earthquake (during the first survey), and (b) after the entire sequence (during the second survey).

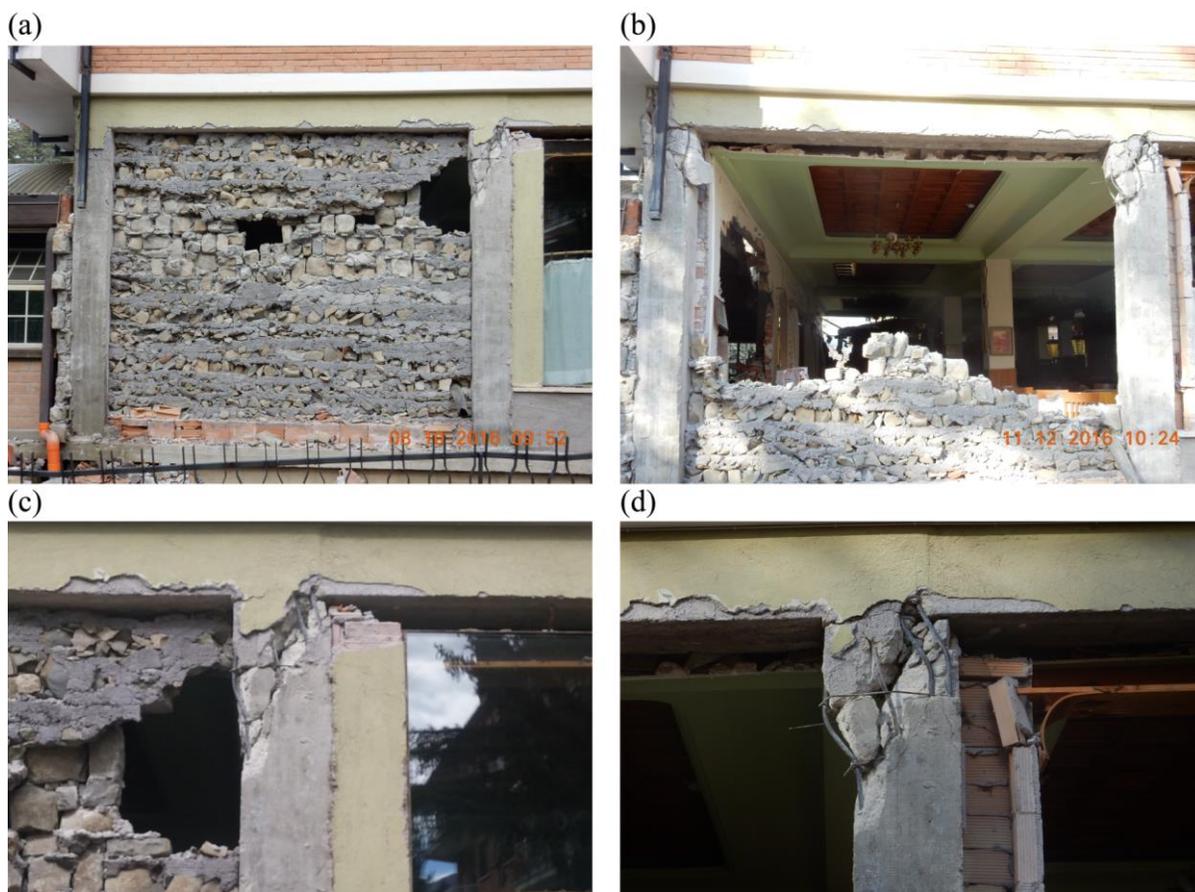
Figure 13. Reinforced concrete residential building (a,c) after the 24 August earthquake and (b,d) after the entire sequence. (a,b) External infill failure and (c,d) shear failure at the column top.

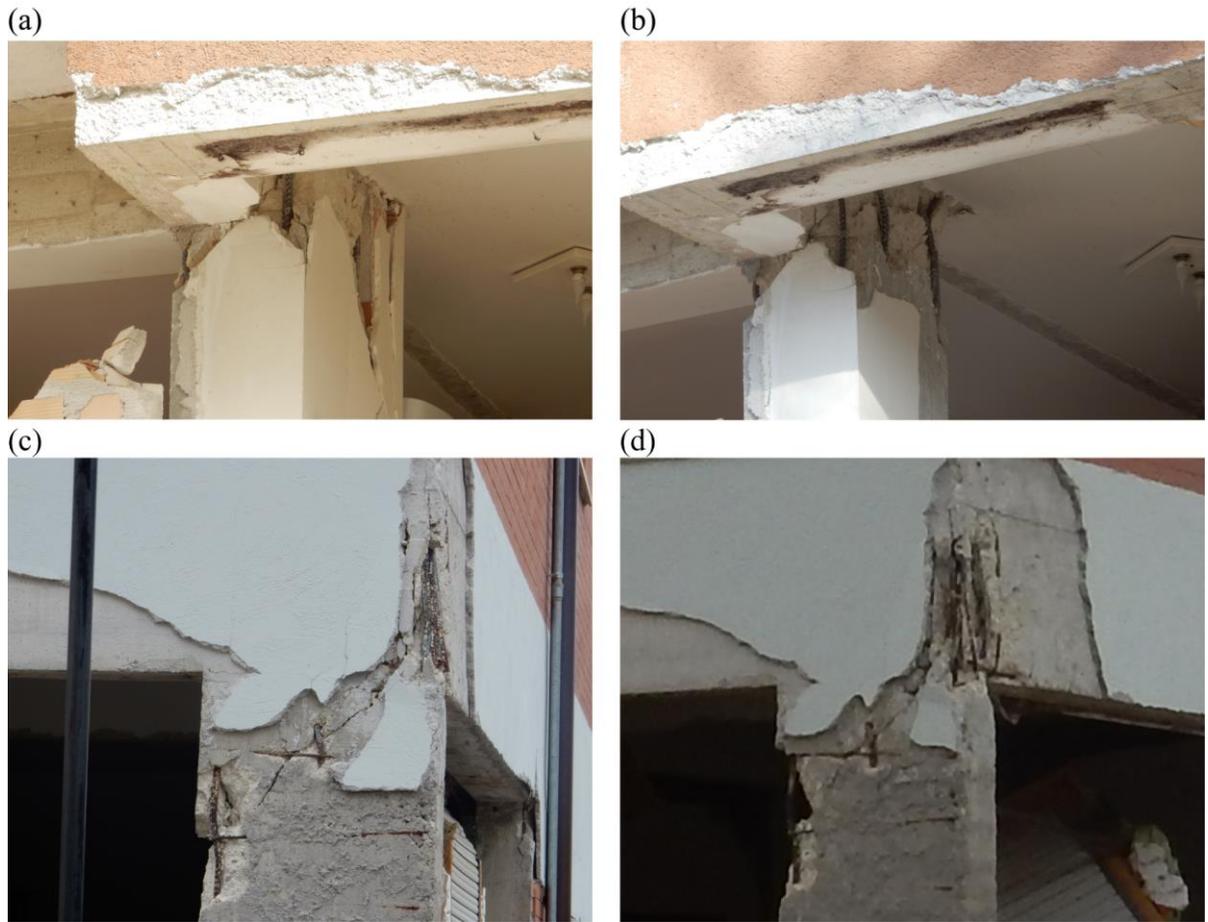
Figure 14. Beam-column joints. Concrete spalling and local bar buckling due to lack of transversal reinforcement after the 24 August event (a,c) and after the earthquake sequence (b,d).

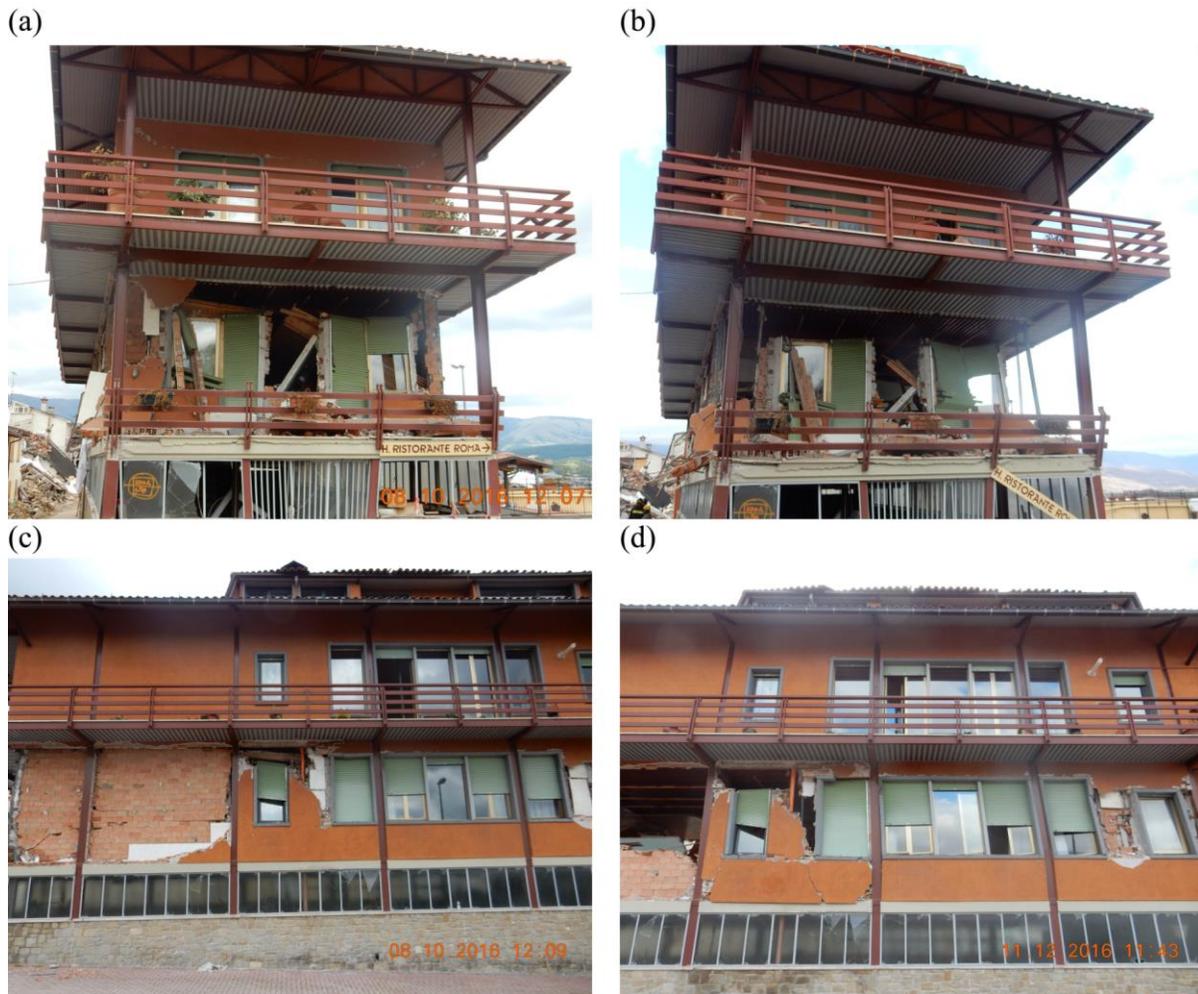
Figure 16. Steel residential building. (a,c) Limited damage after the 24 August earthquake and (b,d) extensive damage of the infill panels at ground level with evident residual drift after the entire sequence.

Such a steel structure consists of a basement, a ground floor, and two upper stories alongside a shorter top story that serves as a penthouse. After the 24 August event, the damage was mainly confined to the infill panels, with only small local flange instabilities observed at the top of two front columns of the ground floor. At the end of the entire seismic sequence, the building experienced permanent deformation along its longer direction, as shown in Figure 16. Such permanent deformation was localized at the second level of the building with a visible residual inter-story drift due to the relative positions of infills and openings. Preliminary finite element analyses of the building confirmed that the fundamental period of the structure is approximately equal to 0.75 sec. This was an uncoupled translational mode along the long side, which was mainly attributed to the orientation of the steel columns with their strong axes aligned with the short side of the building. Naturally, residual drift developed along the longitudinal (weak) axis. Evolution of structural damage is

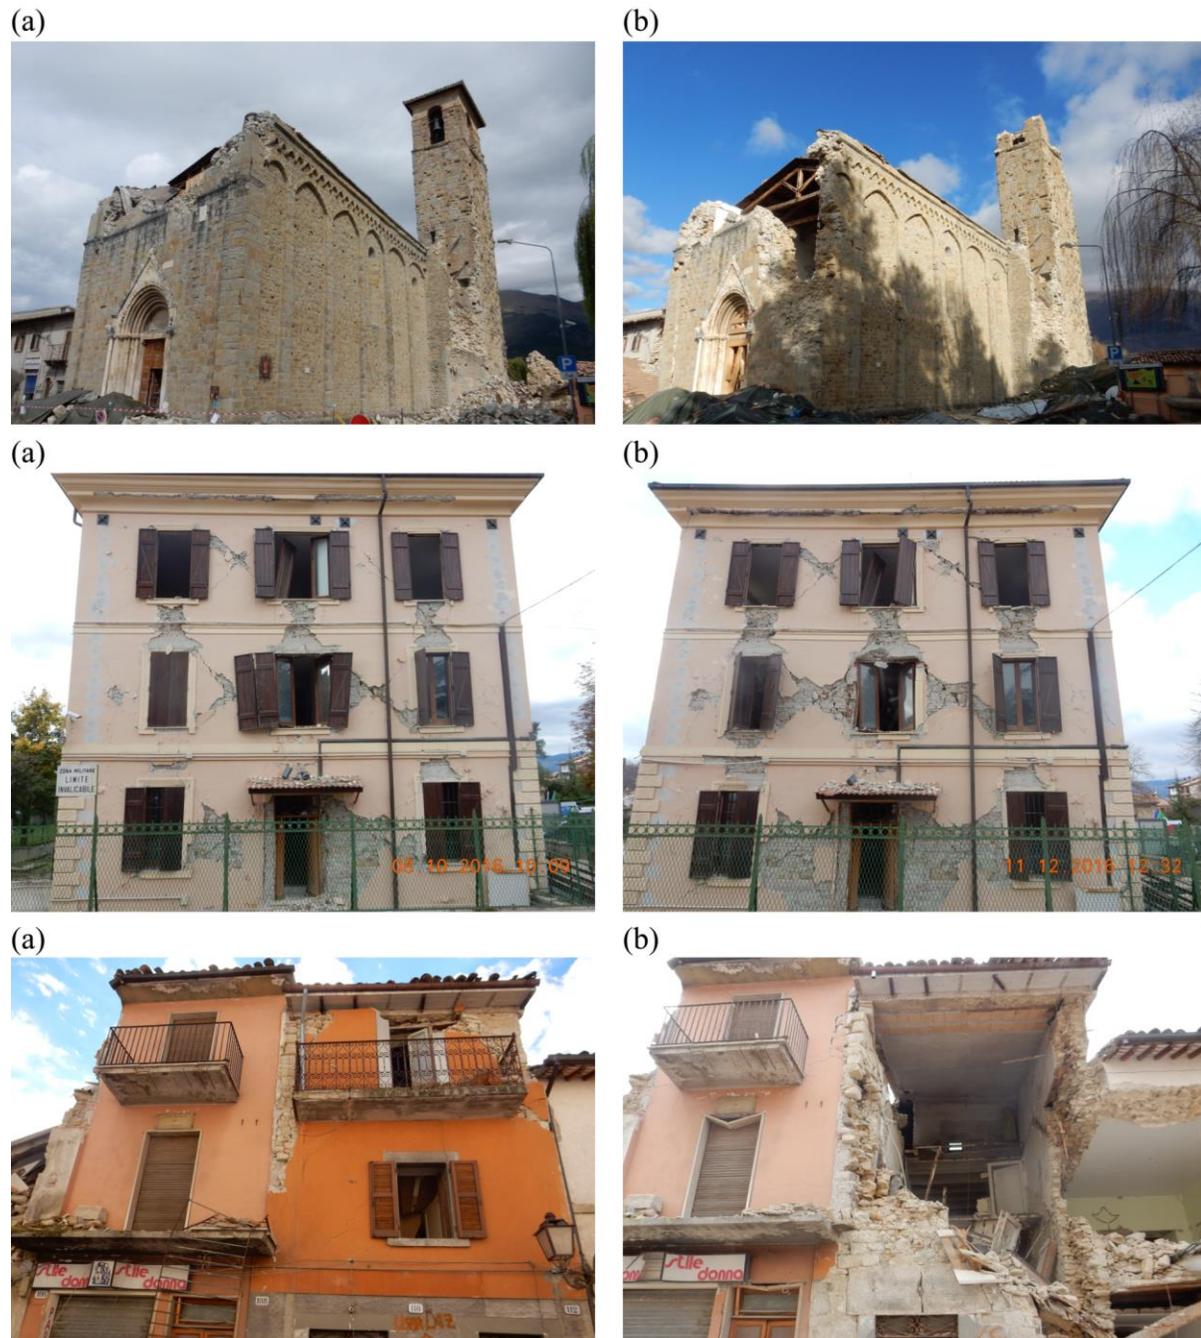
also clearly seen in several characteristic masonry structures, such as the church of Sant'Agostino (Figure 17, top), the local police ("Carabinieri") station (Fig. 17, middle) and typical residential buildings (Fig. 17 bottom and Fig. 18).

Figure 17. Incremental structural damage of the church of Sant'Agostino (top), the local police station (middle) and one of the several masonry buildings collapsed after (a) the event of 24 August earthquake and (b) the entire sequence.

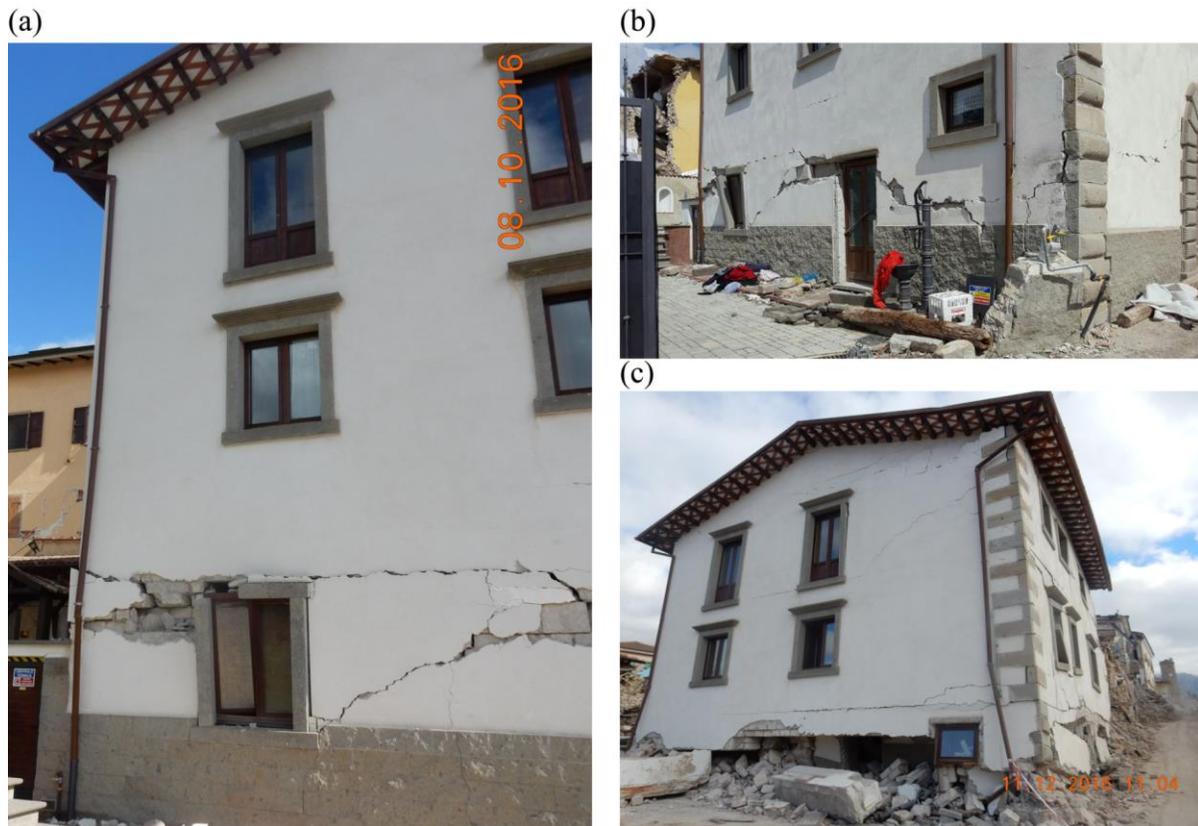
Figure 18. Residential masonry residential building after the 24 August earthquake (a, b) and (c) after the entire sequence. Shear failure of the ground floor bearing wall leads to soft story collapse at the end of the third event.

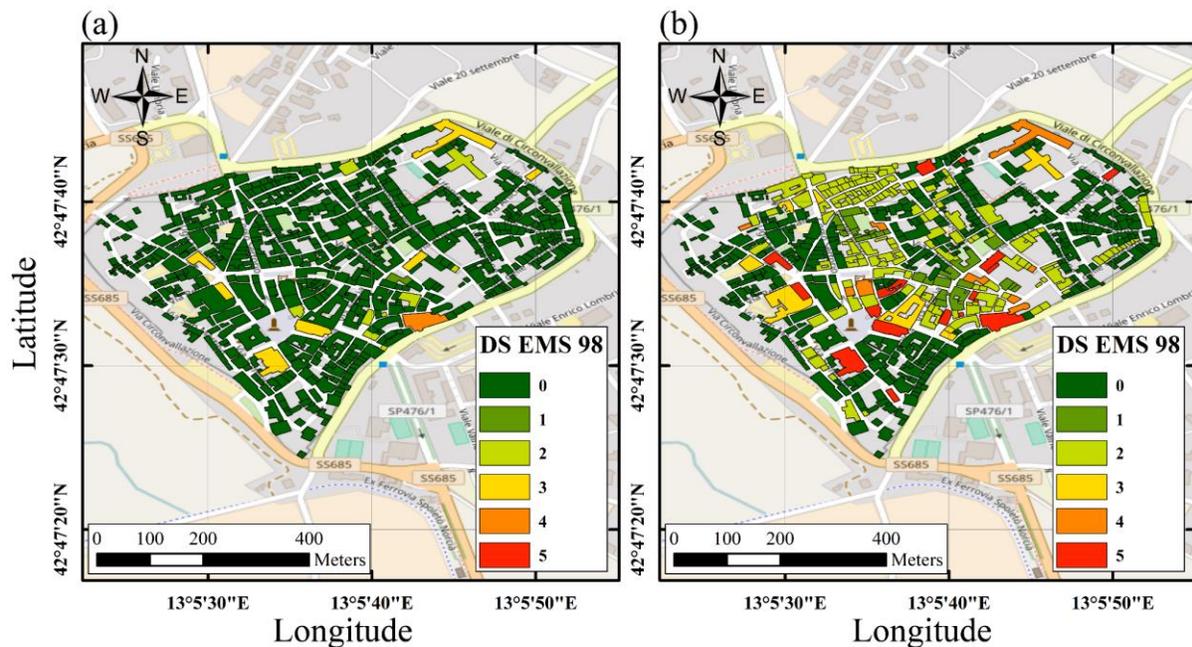
Figure 19 shows the structural damage levels observed during the two inspection campaigns. Following the 24 August earthquake, only a small number of buildings experienced medium or severe damage, located mainly in the historical center of the town. This good performance can be primarily attributed to two reasons. First, after the 1859 earthquake, the reconstruction of Norcia was based on a set of new practical rules of thumb prescribing a minimum wall thickness, the use of buttresses, the reduction of building height, the use of vaults only at ground floor and the mandatory presence of good wall-to-wall connections. The increased wall thickness is still visible in many structures, and in several buildings, the wall thickness varies linearly along the height of the first story. Secondly, a series of repair and strengthening works followed the 1997 Umbria-Marche event, which improved the capacity of sub-standard buildings. Such retrofits are generally not visible from outside, but confining ring-beams and cross-ties can be traced externally in many cases. Despite the adequate structural response of the buildings in Norcia during the 24 August event, a sharp increase of damage, yet not as disproportional as in the case of Amatrice, was

observed at the end of the seismic sequence, mainly in heritage construction such as churches and monasteries. The following variation of cumulative damage was reflected in the statistical distribution of the different damage states: intact buildings (DS0) were reduced from 97% after the first earthquake to 67%, which was a substantial change in structural behavior. Minor damage (DS1) also increased at the end of the entire sequence to 4% from almost 0% after the first event. The same applies to moderate damage (DS2), it increased from 1% to 24%, previously, and to DS5 increased from 0% to 3% in the first event, DS3 and DS4 remaining practically constant.

Figure 19. Damage distribution in the historical center of Norcia (a) after the 24 August event and (b) at the end of the entire seismic sequence.

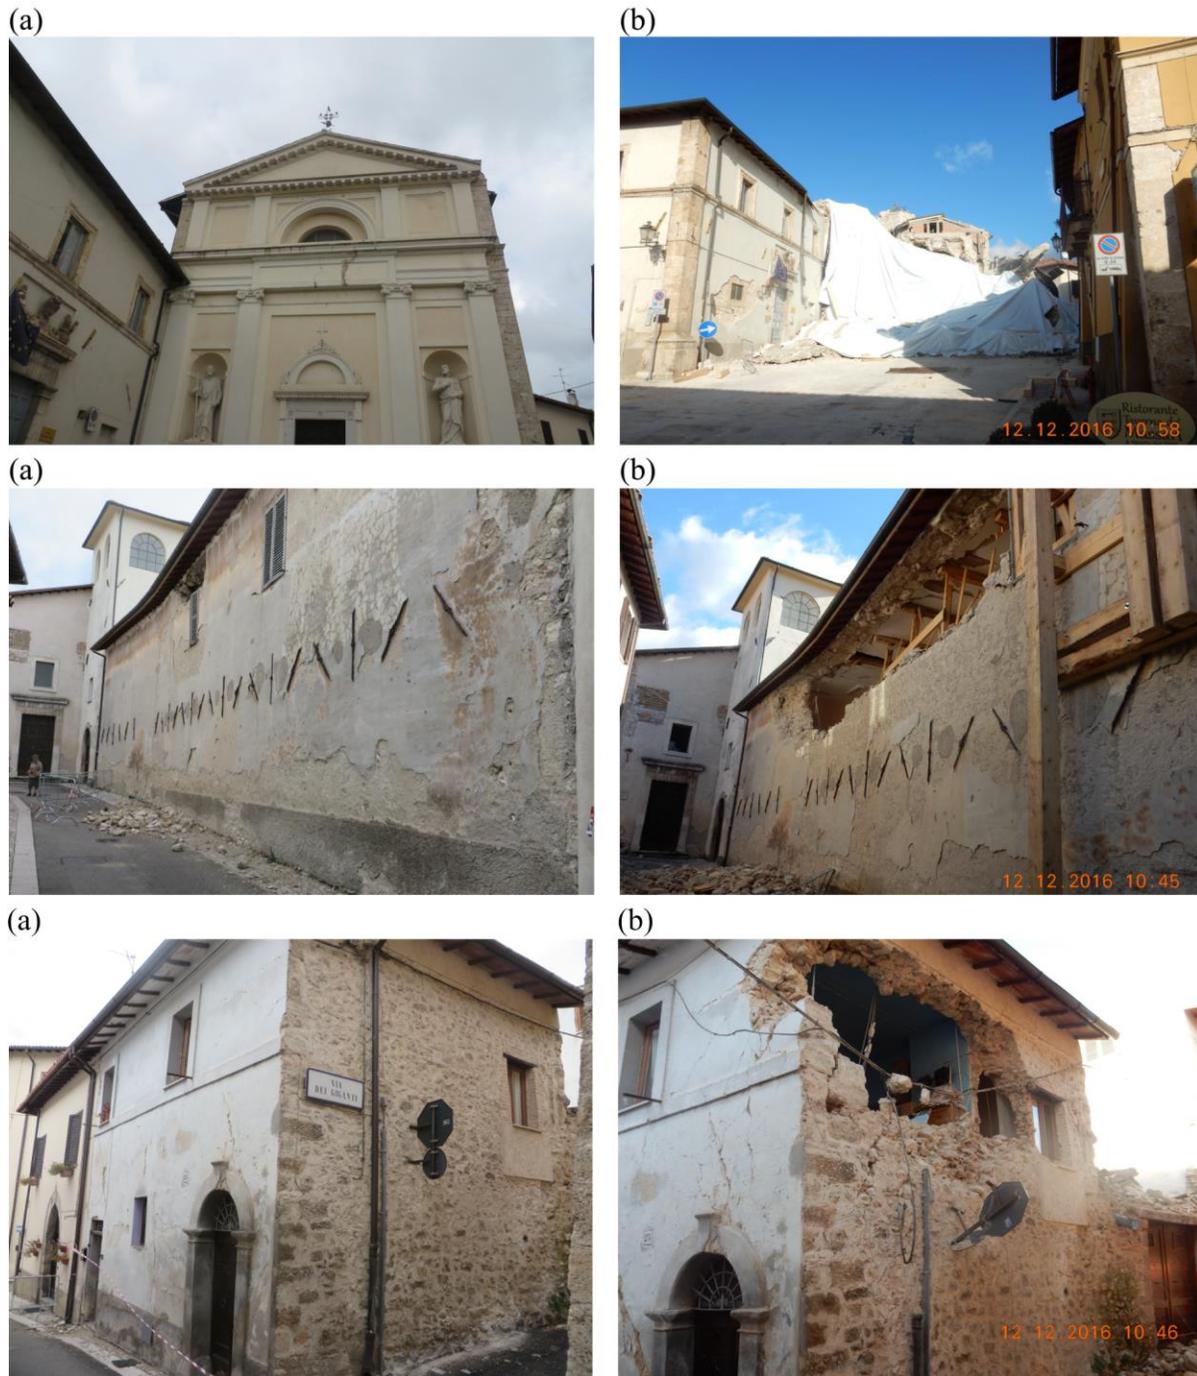
Figure 20 (top) shows one of the churches that was slightly damaged by the **M**6.1 24 August seismic event but collapsed following the **M**6.5 30 October event. Many historical churches in Norcia experienced similar damage evolution, as shown for instance in Figure 20 (middle), where the out-of-plane failure of a historic monastery and the partial loss of support of the roof is depicted. Notably, the wall failure was concentrated at a level higher to that of the seismic retrofit, thus highlighting that the retrofit shall not be only localized on the ground level but also take into consideration the reduced axial load and weak diaphragm action of the masonry walls at the higher level. Figure 20 (bottom) shows two masonry residential buildings with irregular masonry construction that experienced only minor cracking during the first earthquake, but significant out-of-plane and in-plane wall failure under subsequent events.

Figure 20. Seismic damage observed in characteristic masonry buildings (a) after the 24 August earthquake and (b) at the end of the entire seismic sequence.

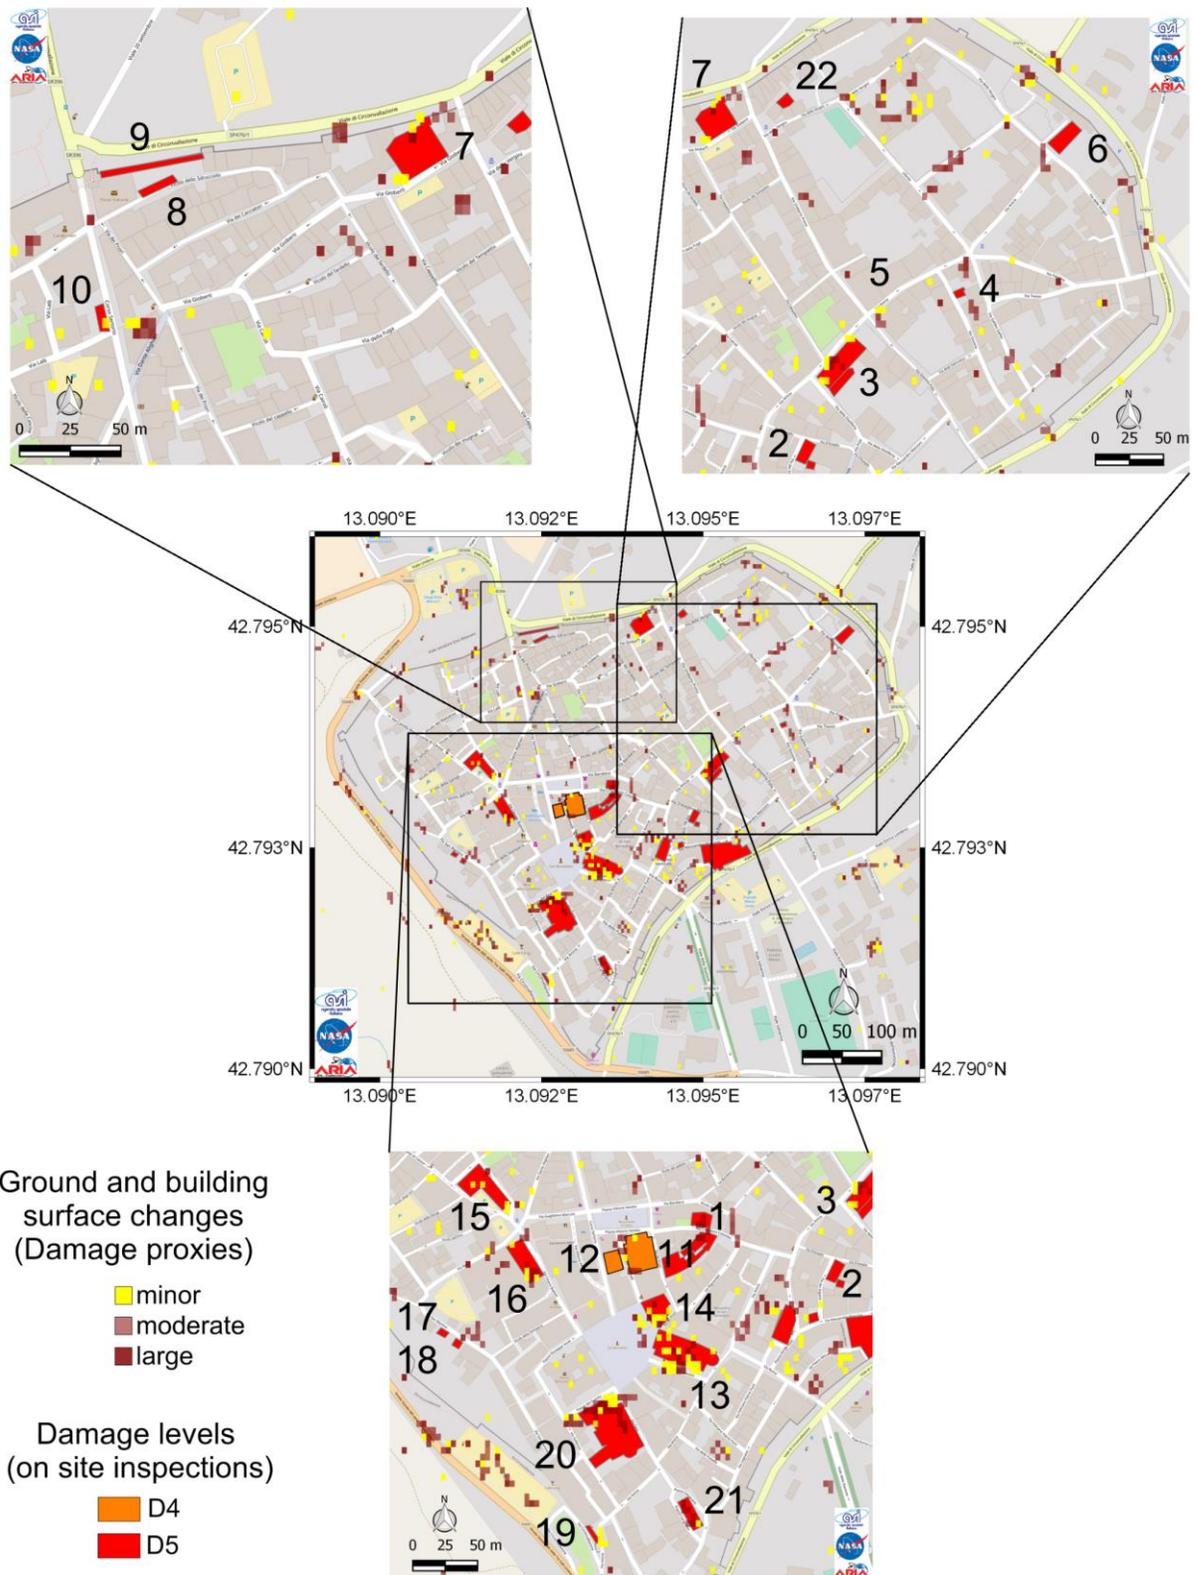
Figure 21 shows the DPM produced for the historical center of Norcia after the **M6.5** 30 October event, that is, the end of the earthquake sequence, superimposed with 22 structures that were classified visually as completely collapsed (D5), and selected D4 structures.

By comparing the locations of these mapped structures and the damage zones from ARIA imaging, a good agreement was observed. In particular, for all structures with an assigned damage level of collapse (D5), the DPM accurately showed a concentration of red and dark red zones, representing areas in which substantial deformations occurred.

Figure 21. Damage proxy map of Norcia, along with the identification numbers of all structures with assigned damage level D5 and selected structures with assigned damage level D4, from field inspections and available high-quality on-site information and photos.
